Biotrial Inc.'s Facilities at 130 Norfolk St., Newark, NJ

Water Issues – History, Research & Testing

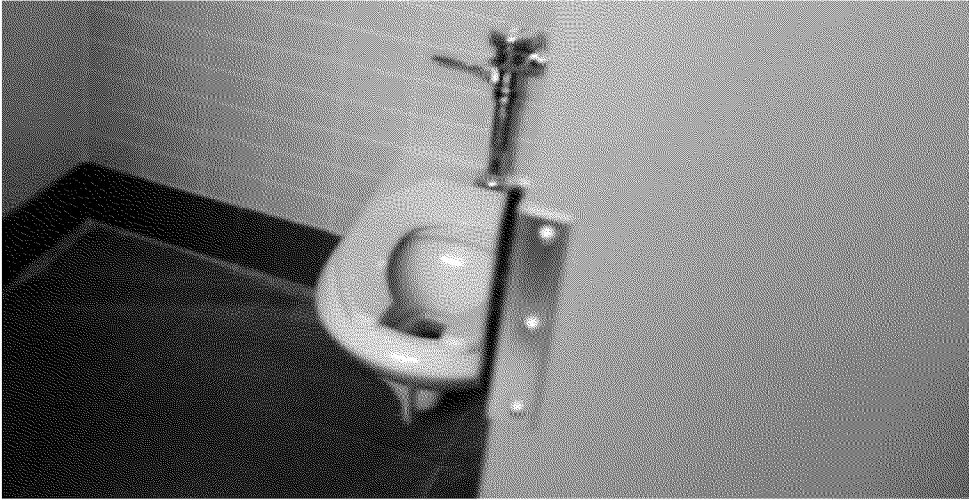
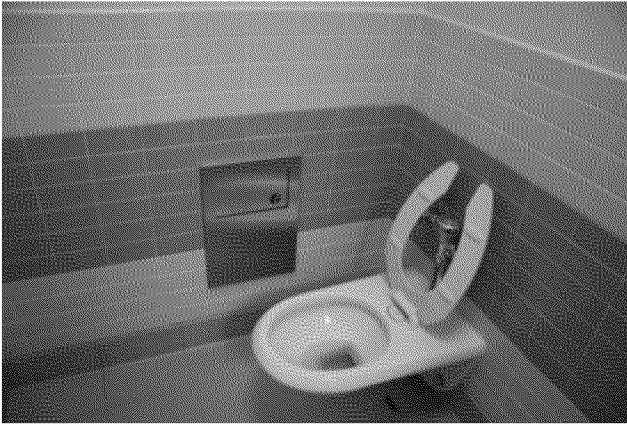
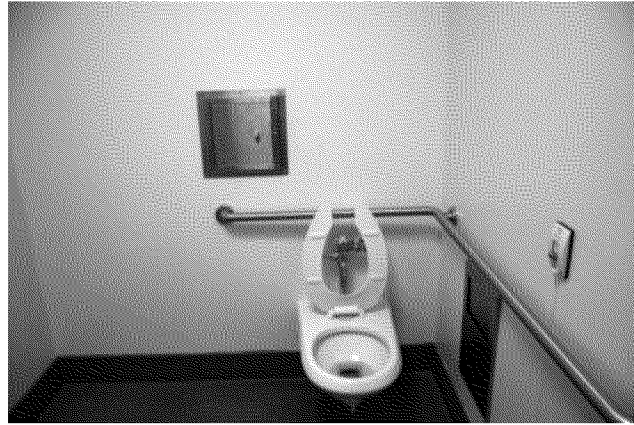
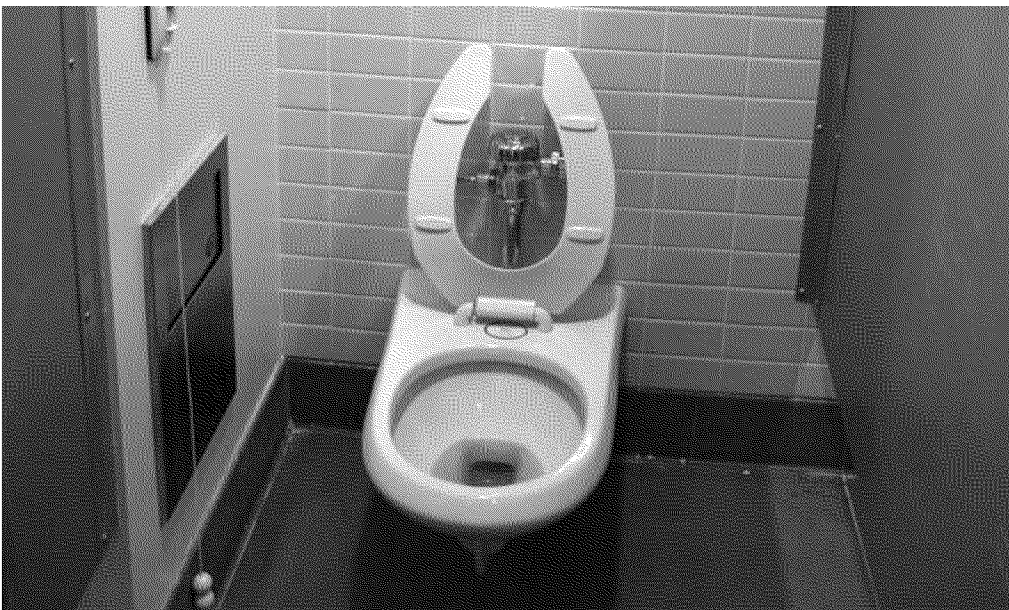
July/August 2015 – Yellow water or yellow stain in toilets in different areas of the building, no actions taken, assumption made that it was due to lack of flushing by on-site crew

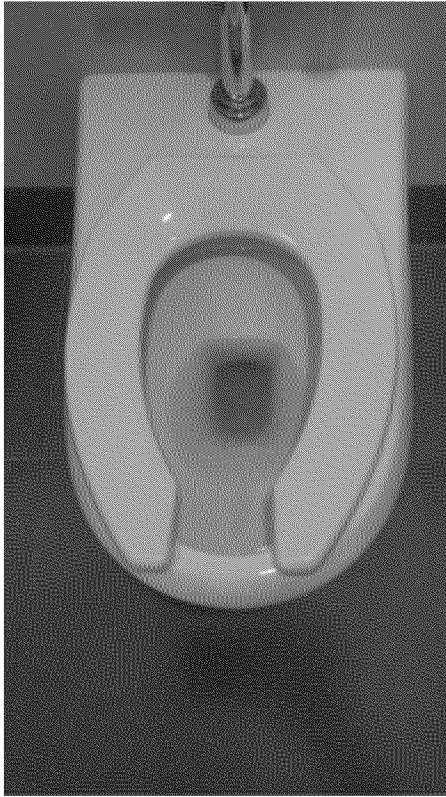
4th Floor:

December 14th, 2015 – Persistent yellow water

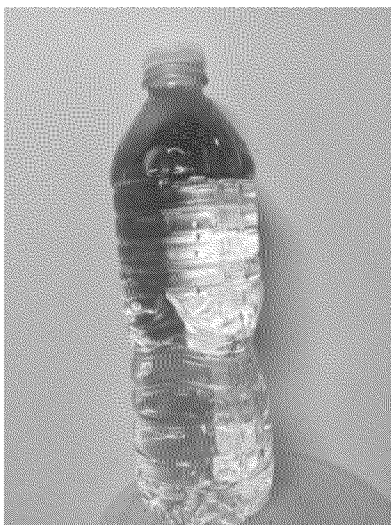
Entry point in Basement:

January 6th, 2016 – Despite chemical flush, persistent yellow and now frothy water (iron levels worst on 3rd floor: 3.31-ppm) Clarity water technologies full system Flush

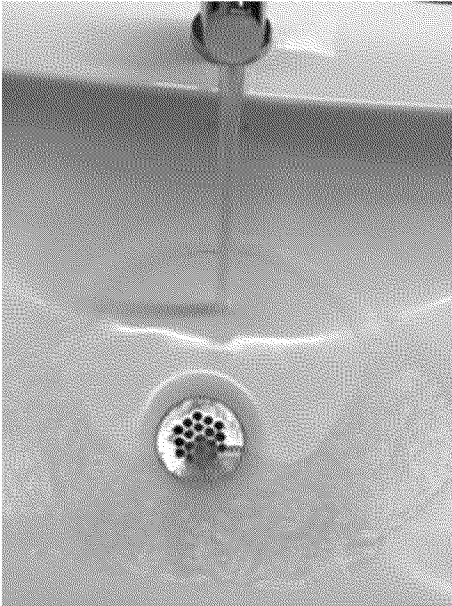
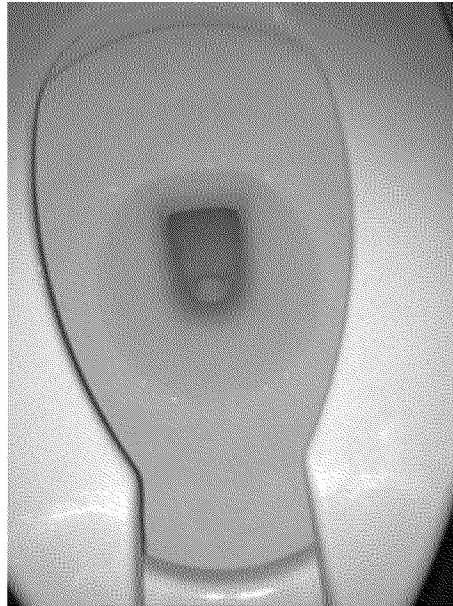
4th Floor:

January 12th, 2016 – Persistent yellow water

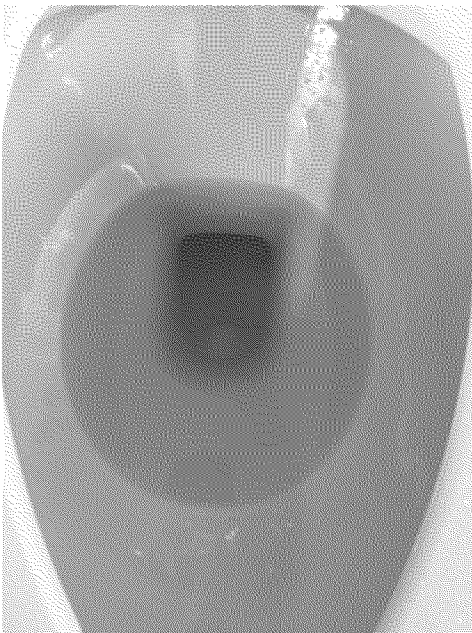
4th Floor:

January 13th, 2016 – GC confirmed that fire protection contractor checked all backflow preventers and found them to be working properly. Persistent yellow water.

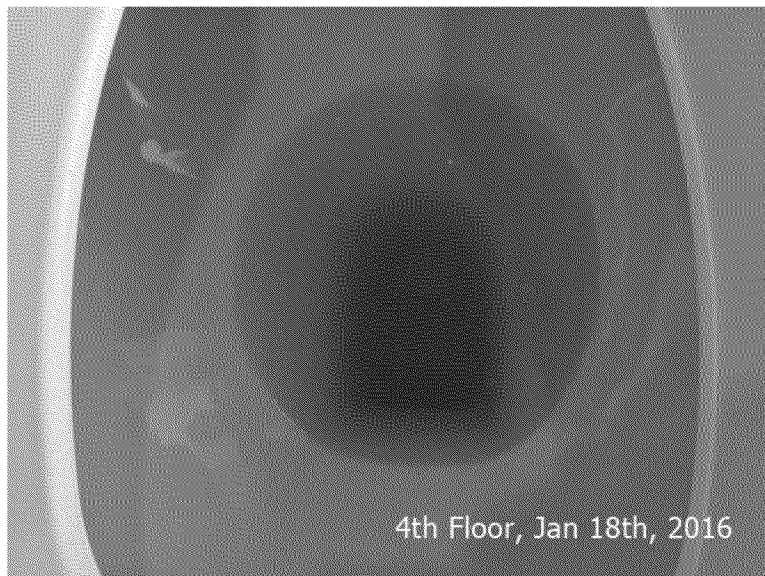
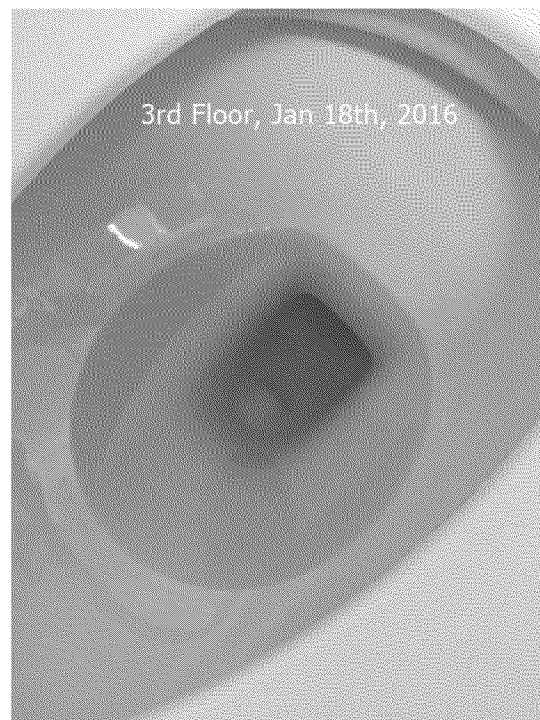
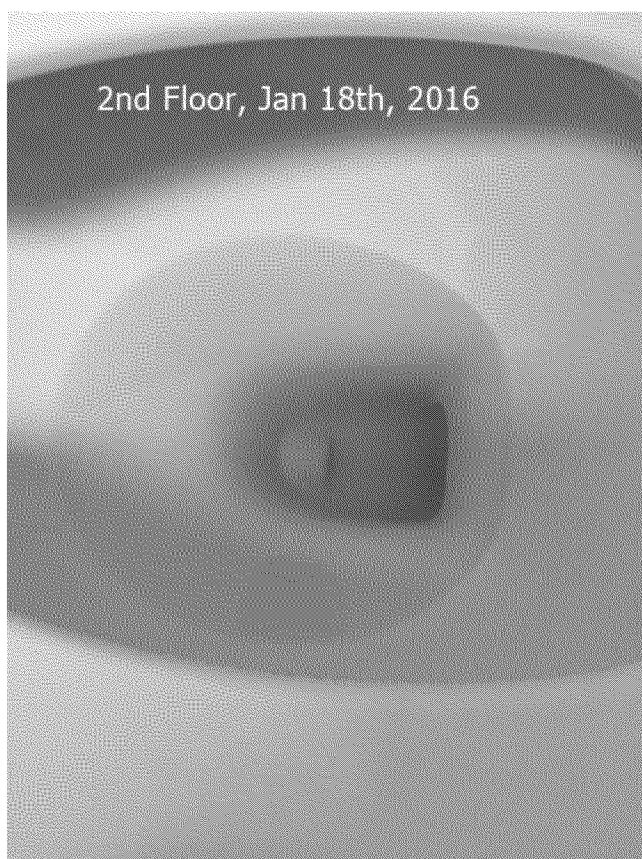
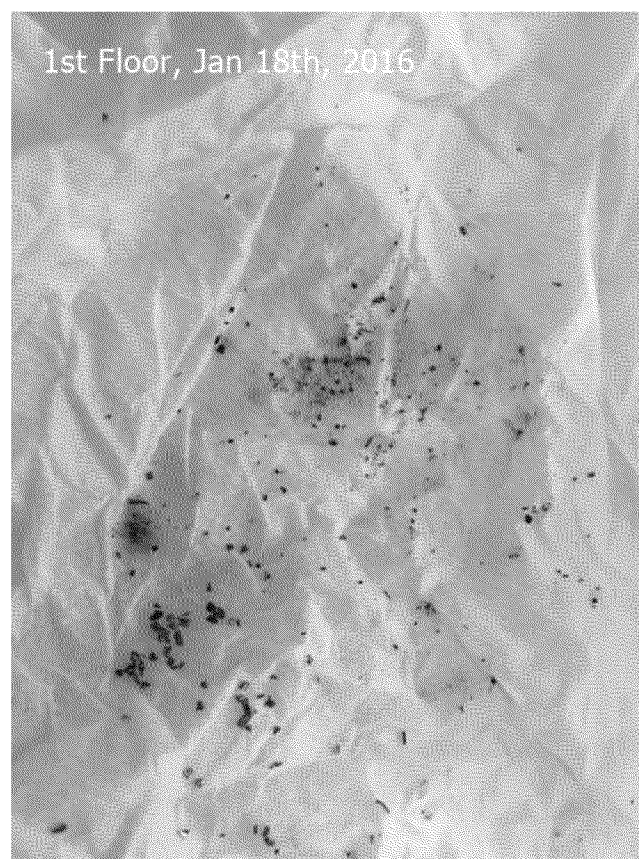
January 18th, 2016 – Persistent yellow water

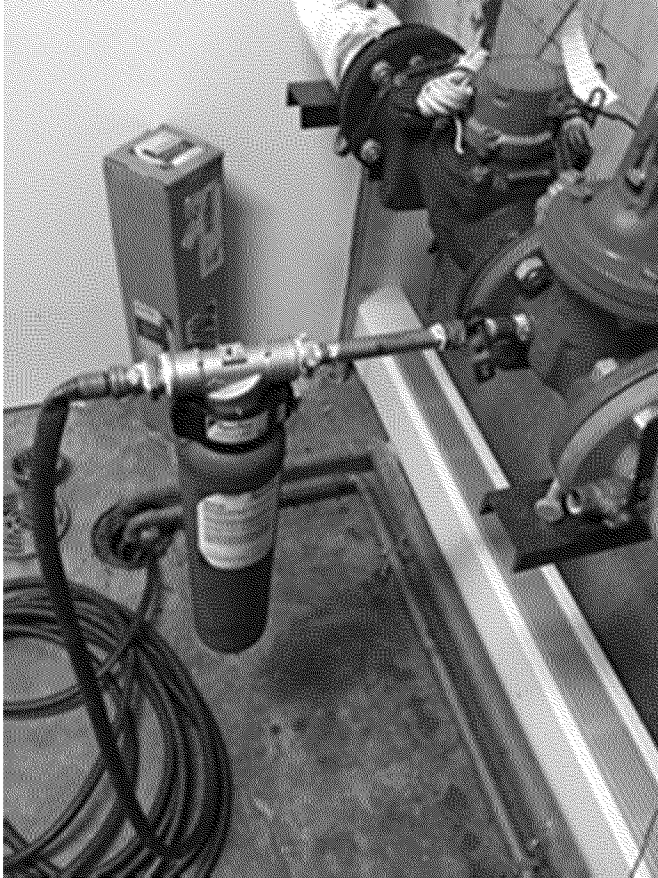
The filter installed on February 26th:

February 26th-March 3rd, 2016 – 5 micron filter installed before back flow preventer, water run through filter continuously. Over the course of one day during this week, 19 water samples were taken from the flow of water after the filter. The water sample as well as the contents analyzed and the results received March 9th. The soluble iron from the 19 samples ranged from under 0.02 to 0.29 mg/l (see **Appendix 3**), and the iron content on the filter was very high – 2,320 mg/kg.

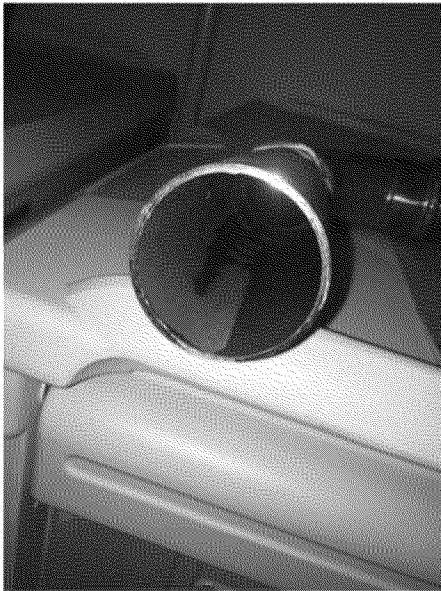
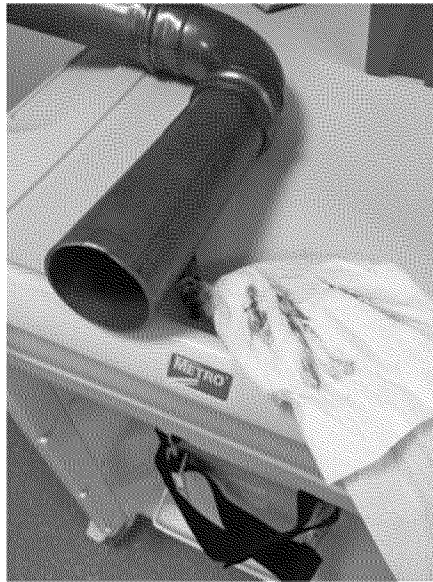
- 2" Pipe from 3rd Floor By Men's Room. Pipe cut with a pipe cutter. No slime layer on vertical or horizontal portion of cut out elbow. Wipe test only showed iron residue on horizontal section. Vertical section wipe test was a slight gray color.

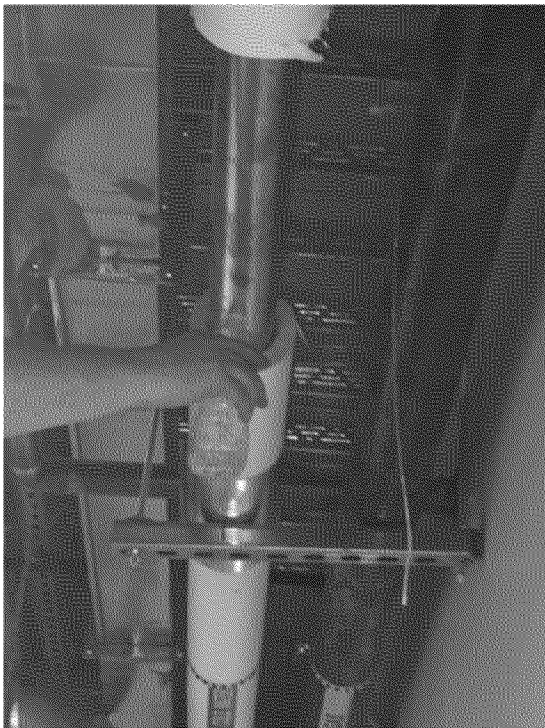
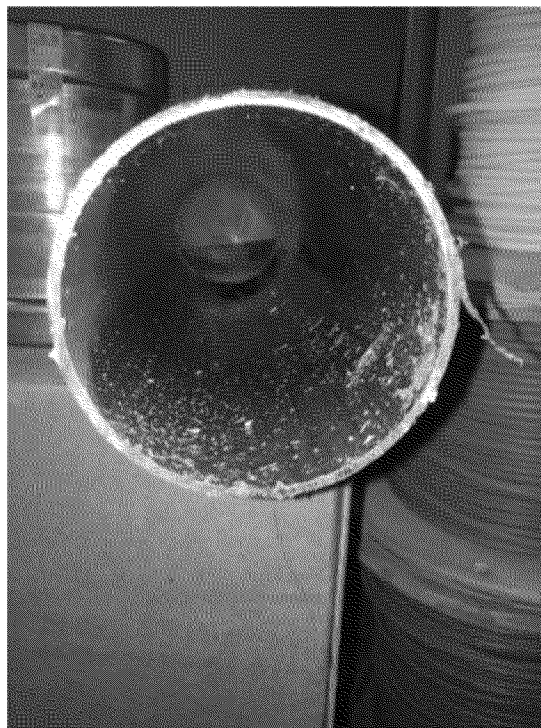
- 3" Pipe from basement. Pipe was cut with a reciprocating saw. No slime layer. Note yellow color of water dripping into plastic bottle from the pipe as it was being cut.
- Heavier deposition of residue is clearly seen in the pipe within the brackets. Copper fines from the sawing are also seen in the inside of the pipe. White flakes are from paint abraded off of new saw blade.

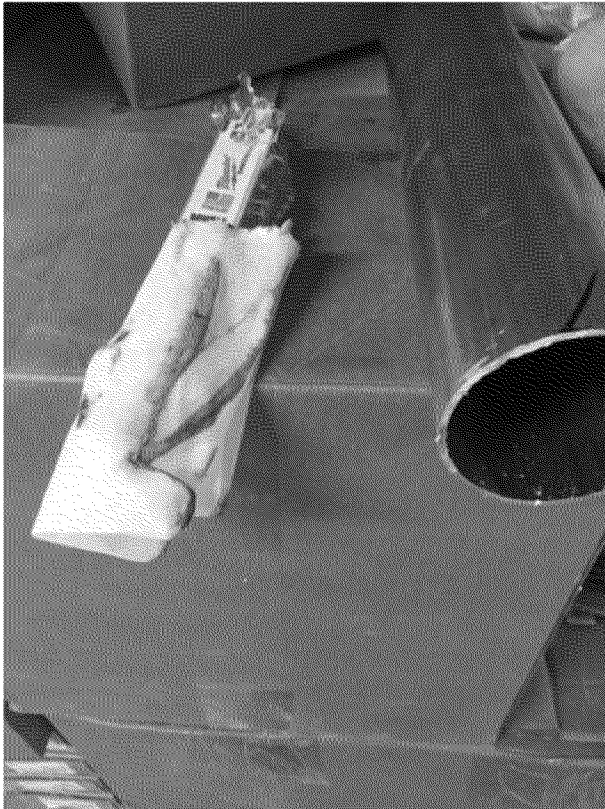
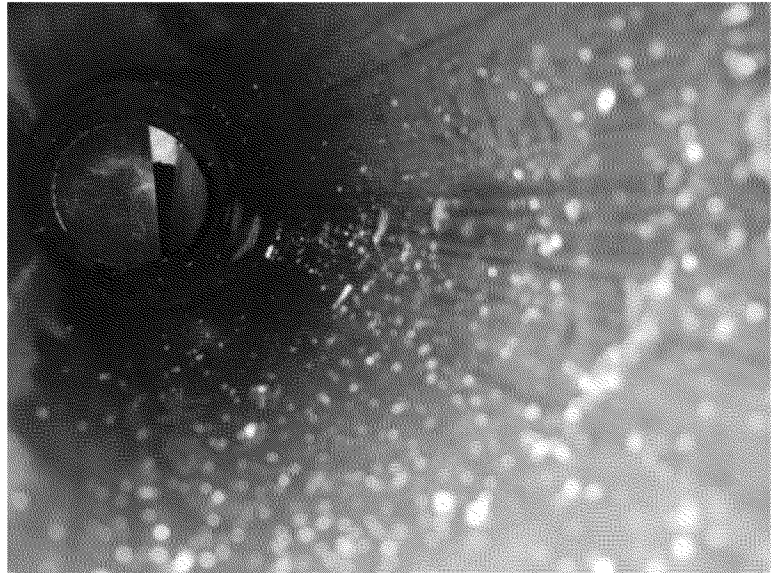
- Wipe of inside of the 3" pipe shows deposition residue.
- Inside of pipe shows discoloration of copper likely due to treatment with chlorine dioxide.

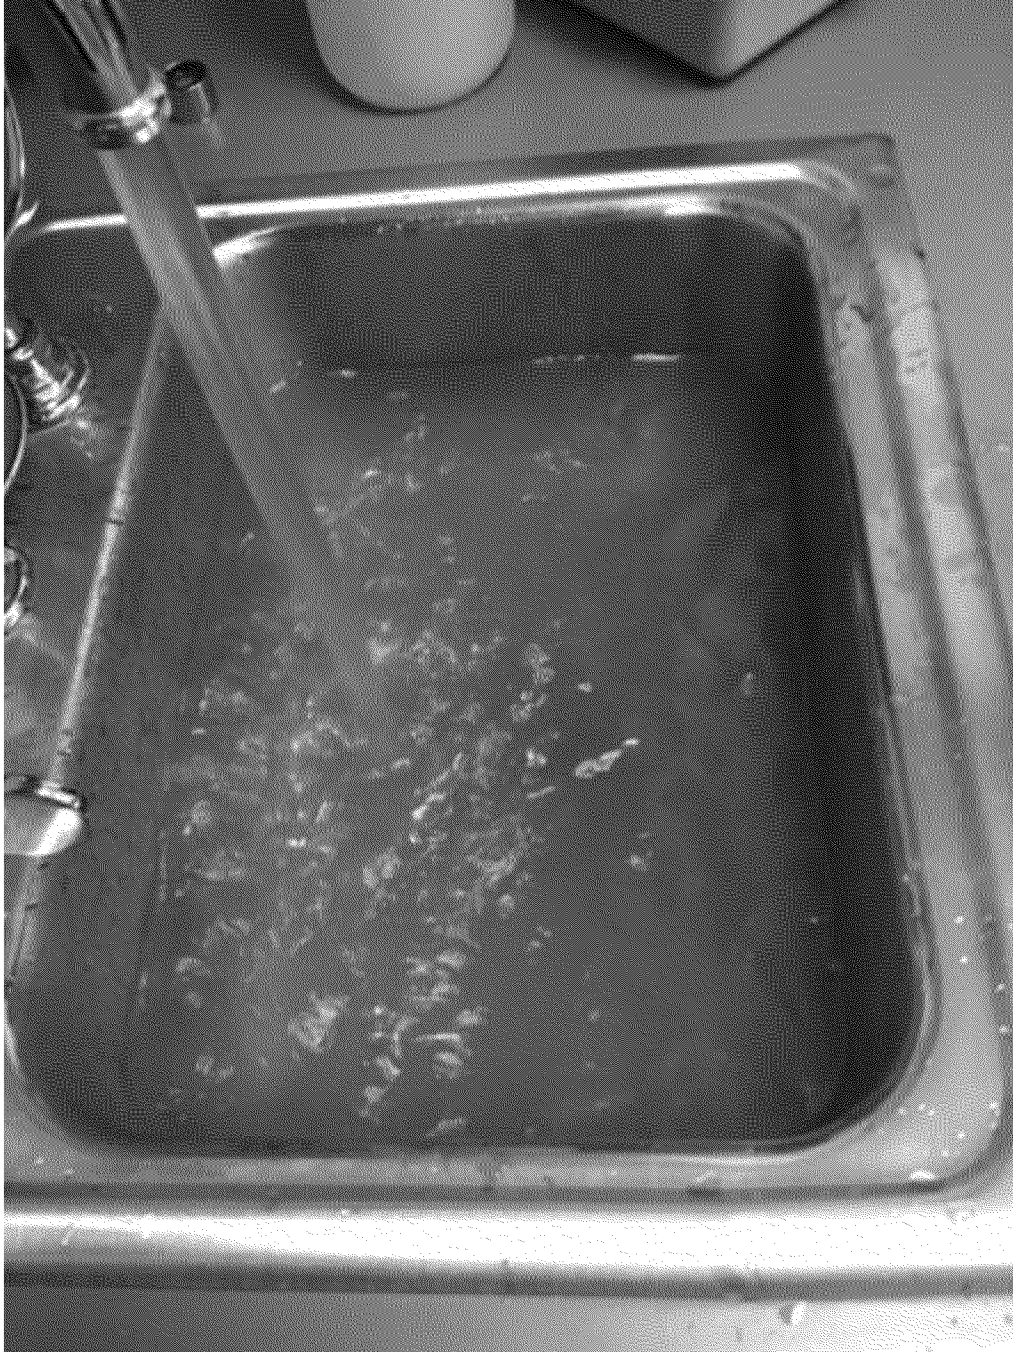
May 4th, 2016 – Condition of water, 2nd floor:

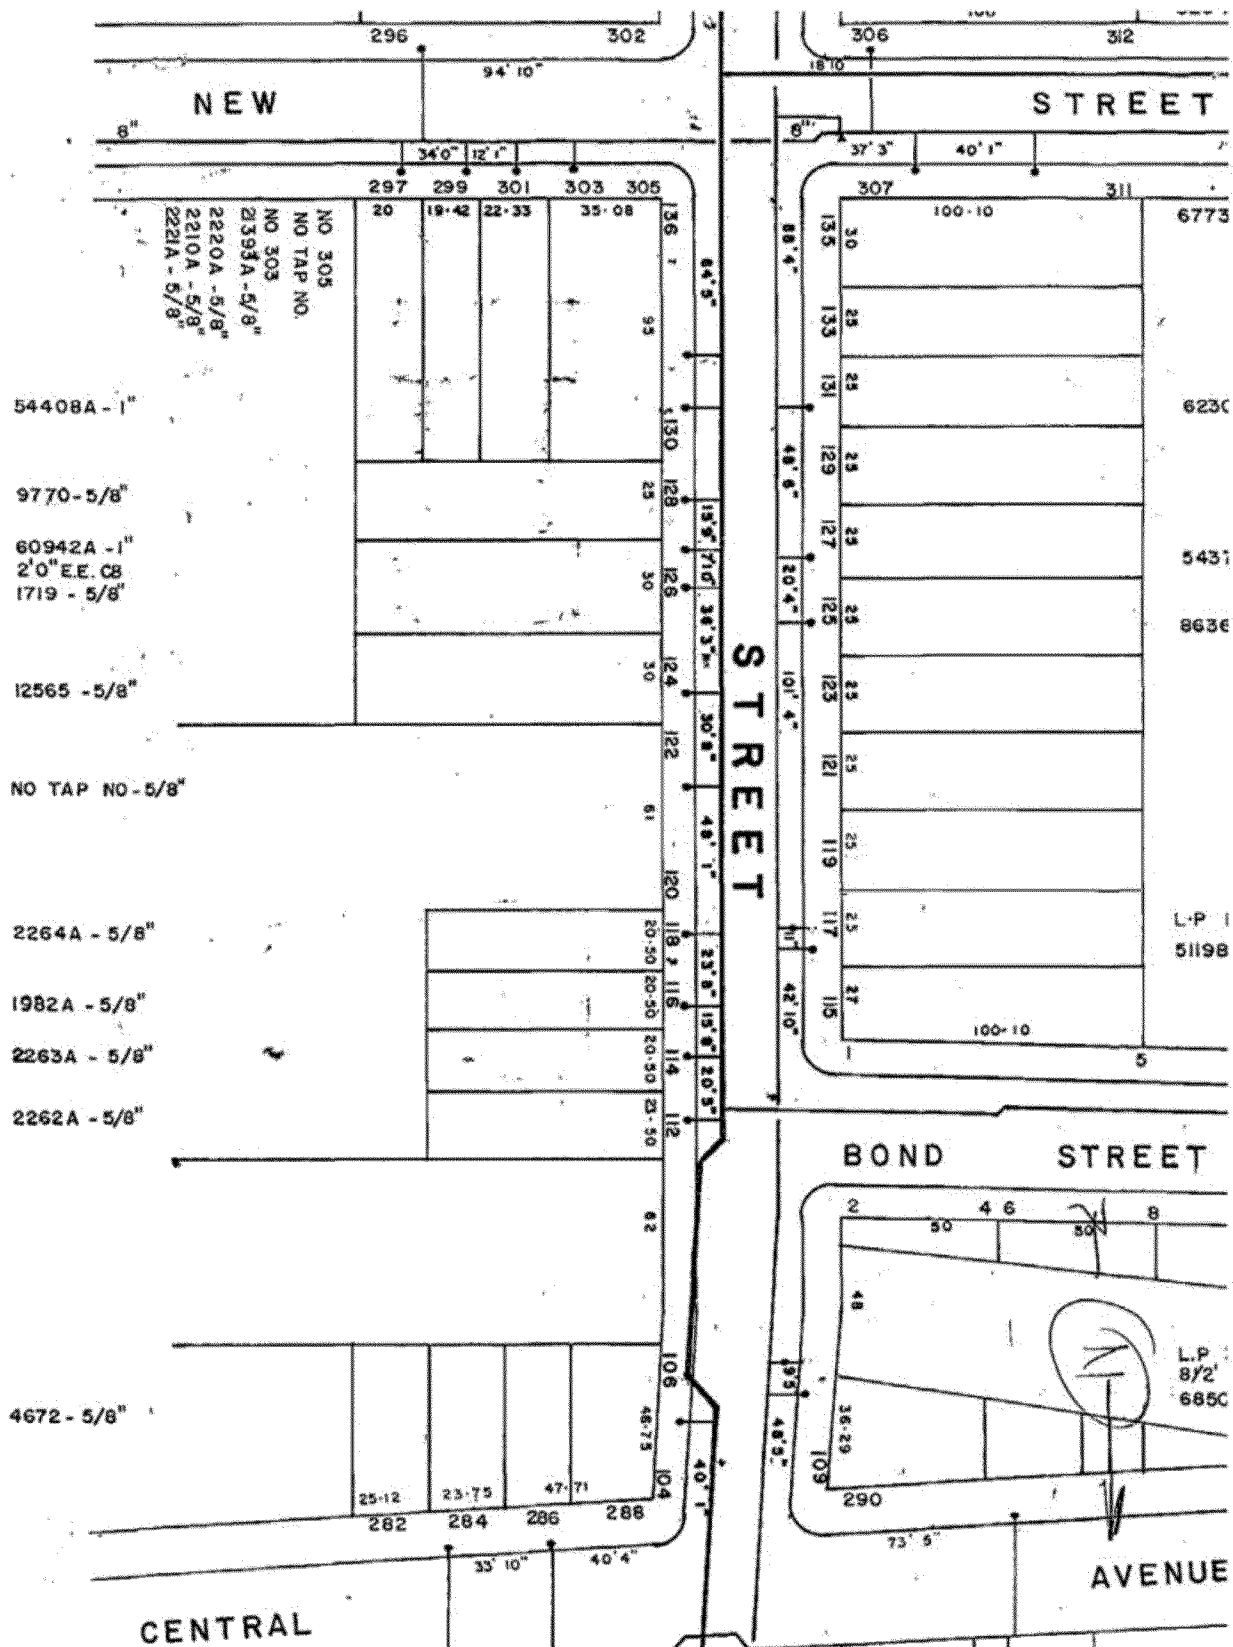
May 12th, 2016 – Upon reviewing a water network engineering drawing (see below, provided by the City of Newark when the city required for old tie-in lines to be capped), it was remarked that it appears that Biotrial is the only entity on the block to be tapped into the 20" service line. All other businesses and residences are tapped into an 8" service line across the street.

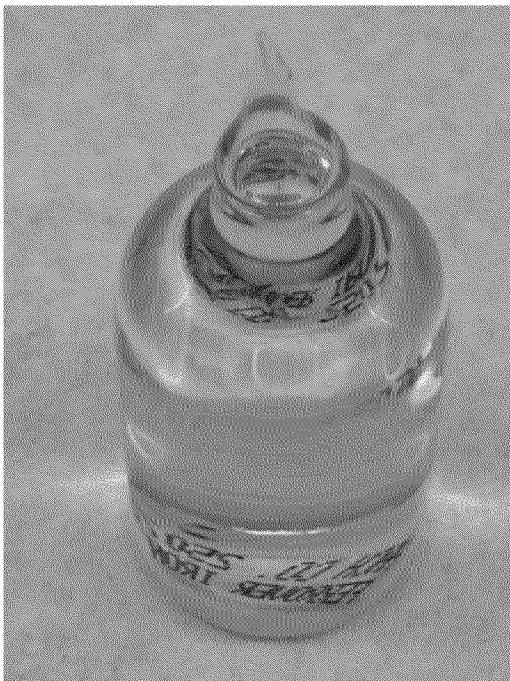
Domestic City Iron

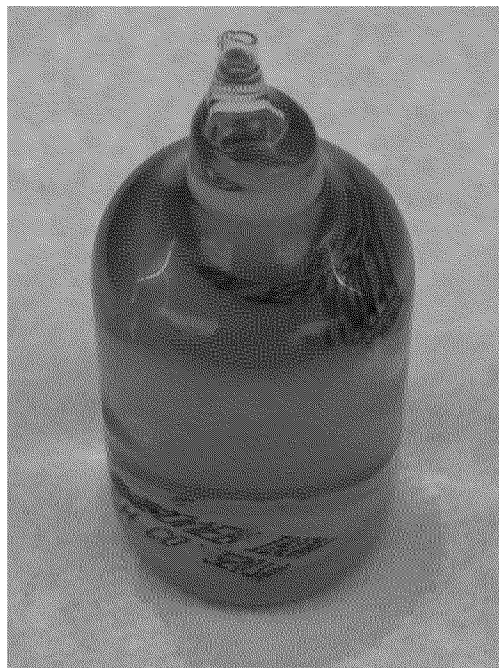
System Iron

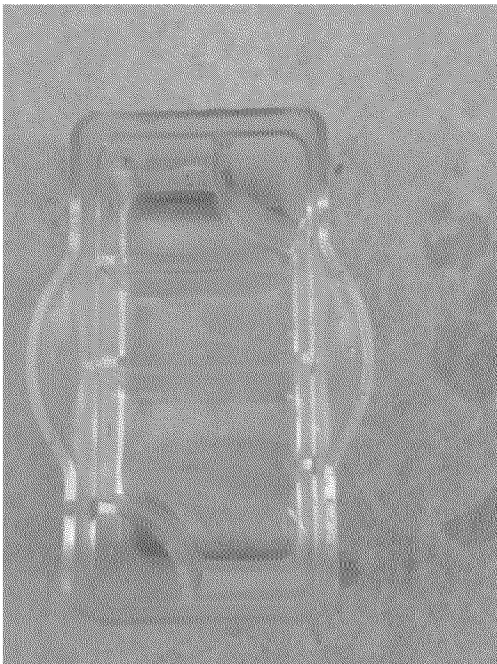
Cold Water Visual 3rd Floor

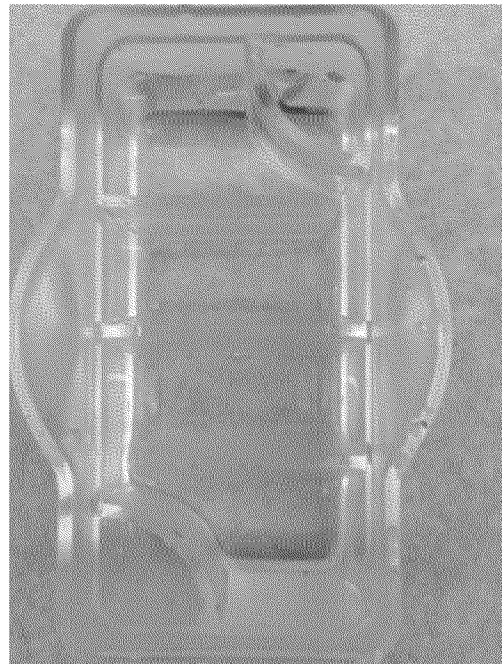
Hot Water Visual 3rd Floor

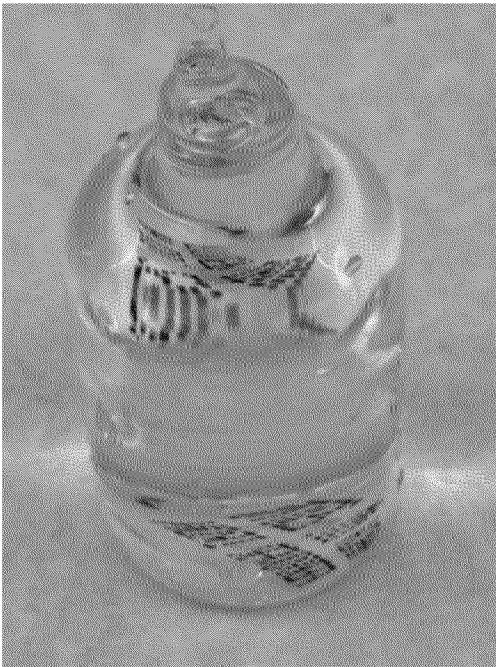
Iron 3rd Floor

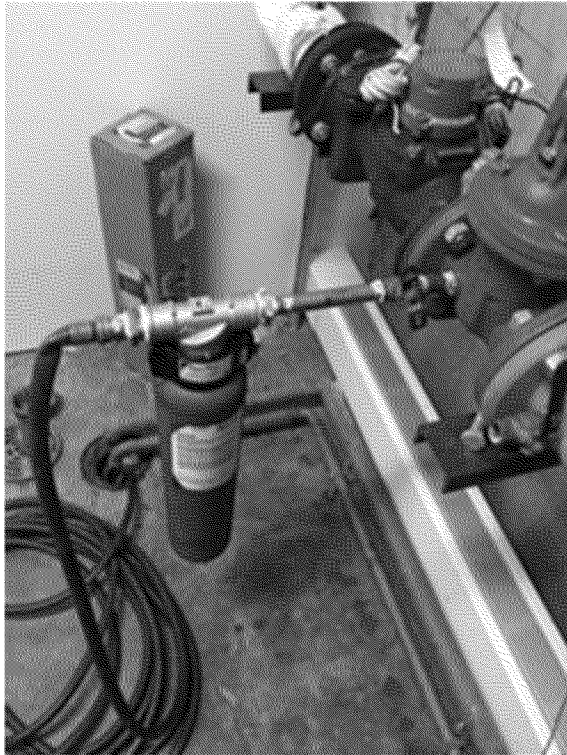
PHOTO 1 shows filter installation

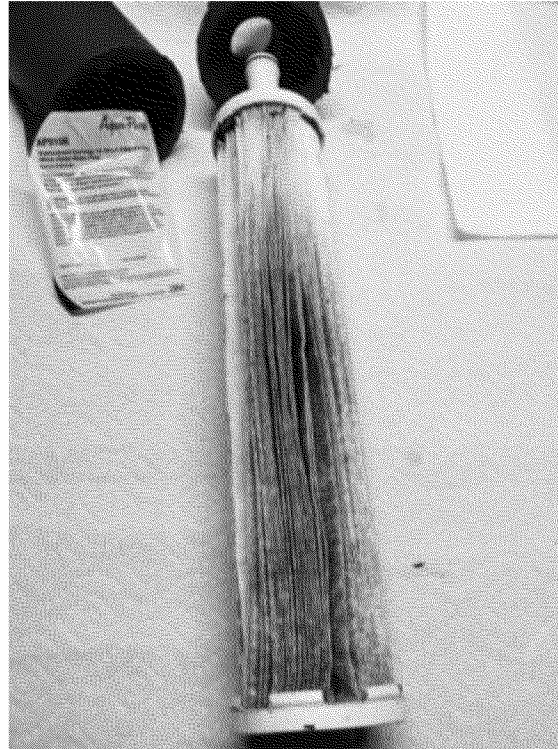
PHOTO 2 shows heavy particulate loading on filter

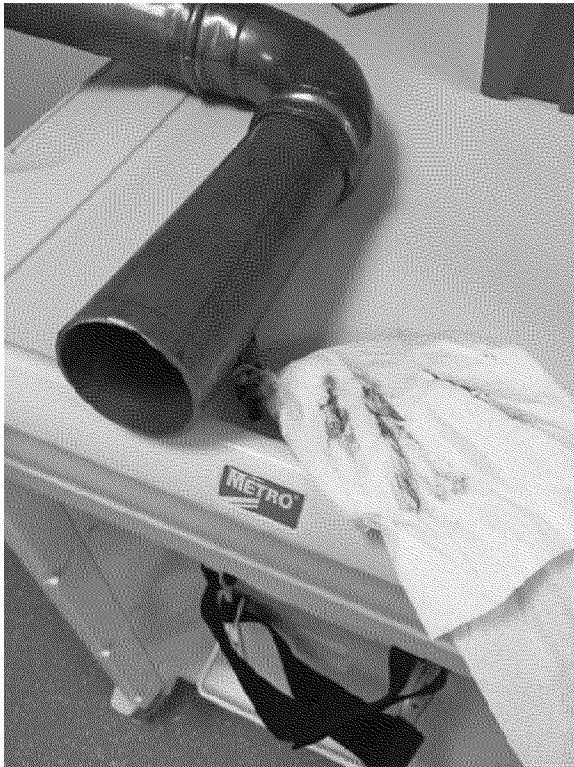
1. 2" pipe from 3rd Floor by Men's Room - pipe was cut with a pipe cutter. No biological slime layer identified on vertical or horizontal portion of cut-out elbow pipe interior. Wipe test showed iron particulate residue on interior of horizontal section (Photo 3). Vertical section wipe was a slight gray color. Indicates that iron particulates settle out in the water.
2. 3" pipe from basement - pipe was cut with a reciprocating saw. Discolored yellow/brown water dripped from the pipe as it was being cut. No biological slime layer was identified on the pipe interior. Residue deposition is clearly seen in the pipe and on wipe (Photo 4).

PHOTO 3 Particulate residue on wipe from pipe interior

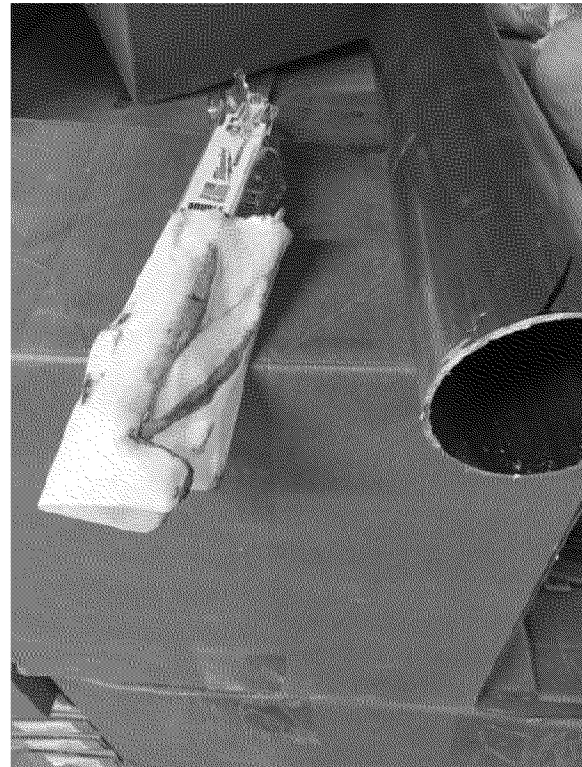
PHOTO 4 Particulate residue on wipe from pipe interior

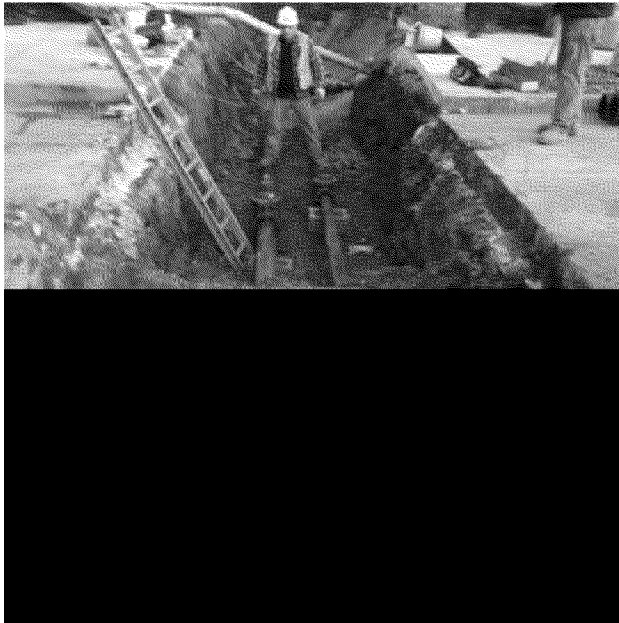
Part 2.01, B, 1; and (2) the service water line is surrounded with aggregate rock so the pipe is not in contact with any soil so iron could not be drawn into the pipe (Photo 5). Additionally, a hydrostatic pressure test was conducted on the service water line after backfilling as required by the City as per Section 331100 – Water Utility Distribution Piping specifications Part 1.05, C.

PHOTO 5 – Aggregate rock backfill around piping
